An infrastructure accountability story: Improving social and economic inclusion in Sekondi-Takoradi, Ghana

CoST – the Infrastructure Transparency Initiative (CoST) promotes transparency, participation and accountability in the delivery of infrastructure projects. It does this through multi-stakeholder working, disclosure of data, an independent review known as the CoST assurance process, and social accountability.

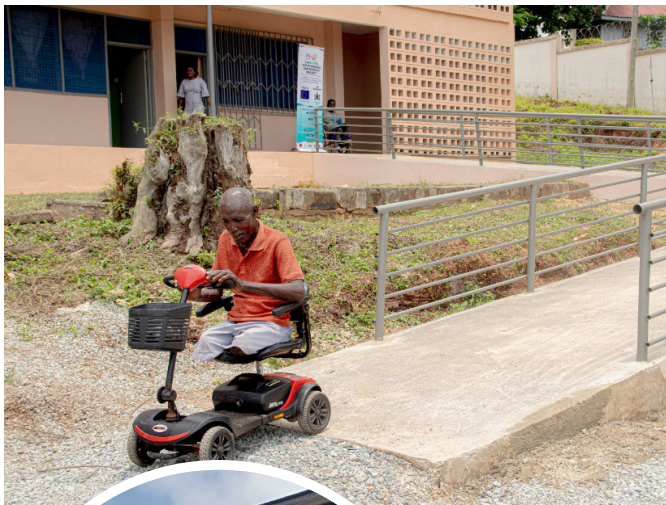
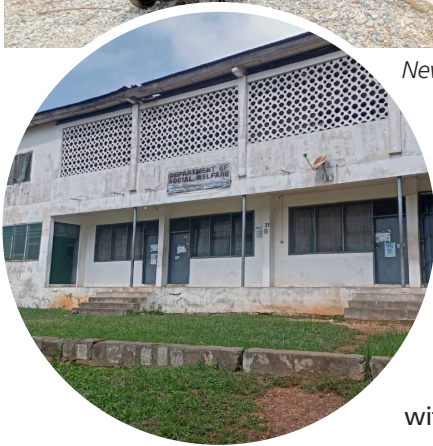
New disability ramp at the Social Welfare Office

Civil society organisations and journalists trained by CoST Sekondi-Takoradi used the report to advocate for inclusion and compliance with the Disability Act. This led to the Assembly installing a ramp at its social welfare office⁴ in September 2022, fast-tracking construction of a school for deaf children and revising the designs of the Sekondi Youth Centre to ensure access for persons with disabilities. The Assembly also mandated implementation of the Disability Act on all public infrastructure projects.

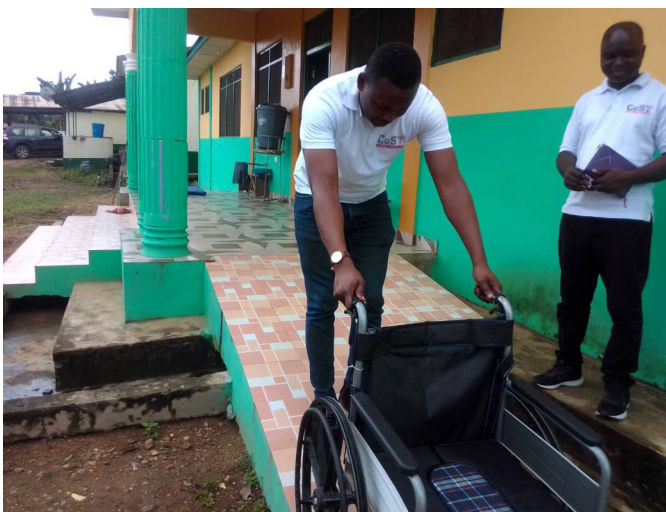
New disability ramp at the Atobiase Health Centre

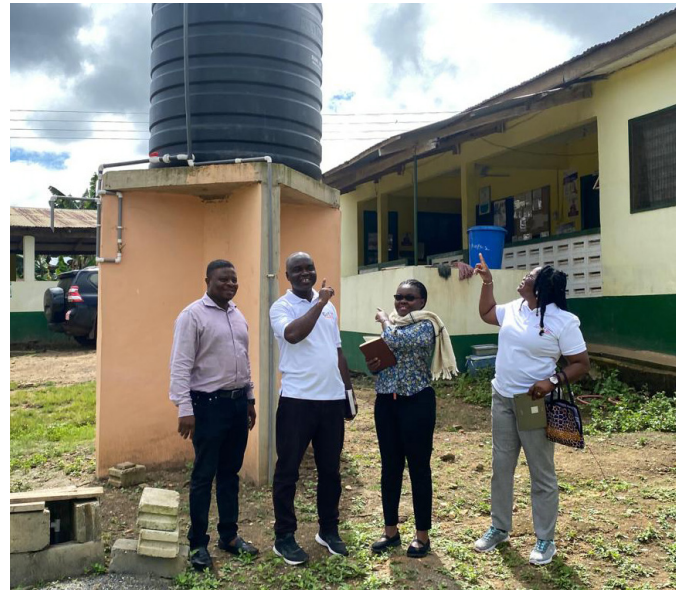
CoST Sekondi-Takoradi helped the delivery of an outpatient building at Atobiase in Wassa East district which had been delayed due to quality problems and funding challenges. It carried out an independent review and highlighted numerous issues in its second assurance report. These included lack of reliable water supply and sanitary facilities, inaccessibility for disabled people and critically ill patients, poor drainage and dilapidated staff accommodation.

A water reservoir constructed at the Atobiase Health Centre

CoST Sekondi-Takoradi held meetings with the district leadership to resolve the quality issues and delay. In response, the district fast-tracked completion of the project, which was opened in October 2023, complete with a new water reservoir, drainage system and access ramps. The facility was also upgraded to a health centre equipped with facilities for childbirth, minor surgery and other health support, and became eligible for annual upgrades.

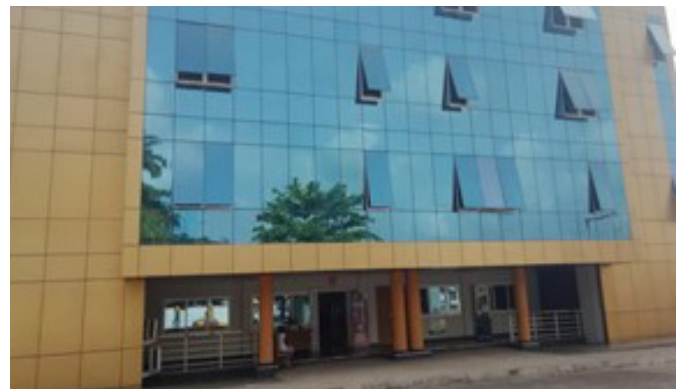
CoST Sekondi-Takoradi’s first assurance report highlighted ongoing challenges in the construction of Takoradi’s main library. This included a dysfunctional lift suffering from an unstable electricity supply as well as outstanding stair balustrades, washroom partitioning and tiling, and wall copings. The project also lacked directional signage and the public thought it was private property.

Takoradi's main library

In June 2023, the contractor responded to CoST Sekondi-Takoradi’s recommendations by fitting a stabilizer to make the lift work properly and installing gender partitions in the washrooms and project signage. The library is now used by the public on a daily basis.

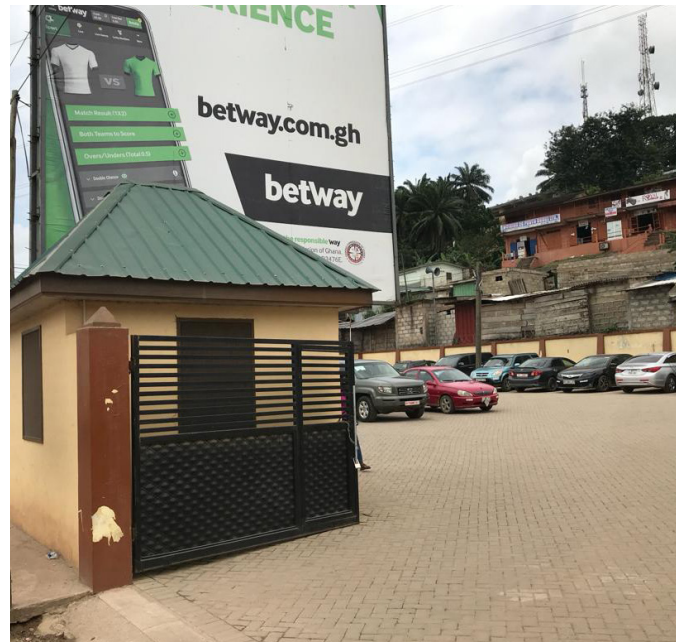
The CoST Sekondi-Takoradi second assurance report highlighted that the contractor was not meeting health and safety standards, was not using warning signs for the public and lacked equipment for testing materials. The report recommended using a small laboratory to perform basic quality tests and engaging a well-resourced third party to assist in ensuring quality compliance.

New car park

In response the Assembly partnered with the University of Mines and Natural Resources to conduct quality tests on the construction materials. In February 2022, the contractor started to install warning signs on the project, provided personal protective equipment for workers, enhanced site management and fast-tracked completion.

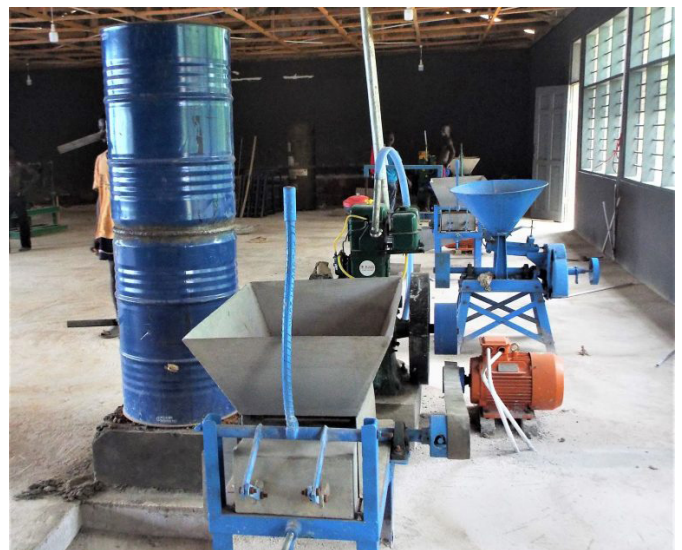
CoST Sekondi-Takoradi's first assurance report independently reviewed the stalled construction of a cassava processing factory at Bokro by the Nzema East Assembly. The project, which was 23 months late by December 2020, had effectively been abandoned following delays in paying the contractor's claims and ill-health. There were also logistical challenges as the project was 35 km from the Assembly's offices, which had reduced visits by the supervising engineer. Furthermore, no site inspector had been assigned. The unfinished building was also discovered to have a leaking roof and the payment certificates were found to be based on quantity not quality.

Cassava Processing Factory, Bokro

The CoST Sekondi-Takoradi multi-stakeholder group recommended getting the defects repaired and exploring alternative measures to get the works completed. A site inspector was assigned and, in 2022, a year after the assurance report was published, the project was completed with all highlighted concerns fixed. Local women, who previously washed and dried their cassava crops on the roadside, can now do so in a clean and safe environment, improving the quality and value of their produce and increasing their sales.

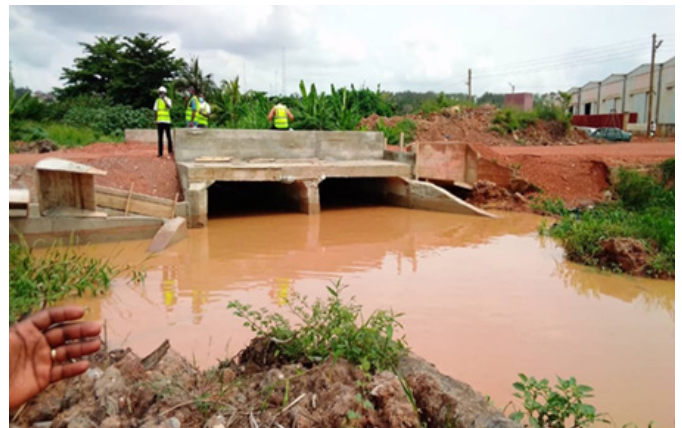
CoST Sekondi-Takoradi’s second assurance report led to changes in rehabilitation of 1.6 km of the WAMCO-Effiakuma road being undertaken by Effia-Kwesimintsim Municipal Assembly. The report highlighted concerns regarding the functional integrity of a new box culvert under the road that had not been de-silted, putting the road at risk of flooding. The old and new culverts were also not linked, leading to rain water flowing between them and undermining the road sub-base.

New box culvert to reduce flood risk

CoST Sekondi-Takoradi recommended that the Assembly undertake regular de-silting to ensure the culverts operated at full capacity. The report also recommended installing retaining walls either side of the road to link the old and new culverts. By early 2022, the Assembly had instituted regular de-silting of the culverts and installed retaining walls to link them. The road is no longer being flooded or eroded.
